Big Heart Pet Brands, Line #8 Test Results

May 19, 2015

Introduction

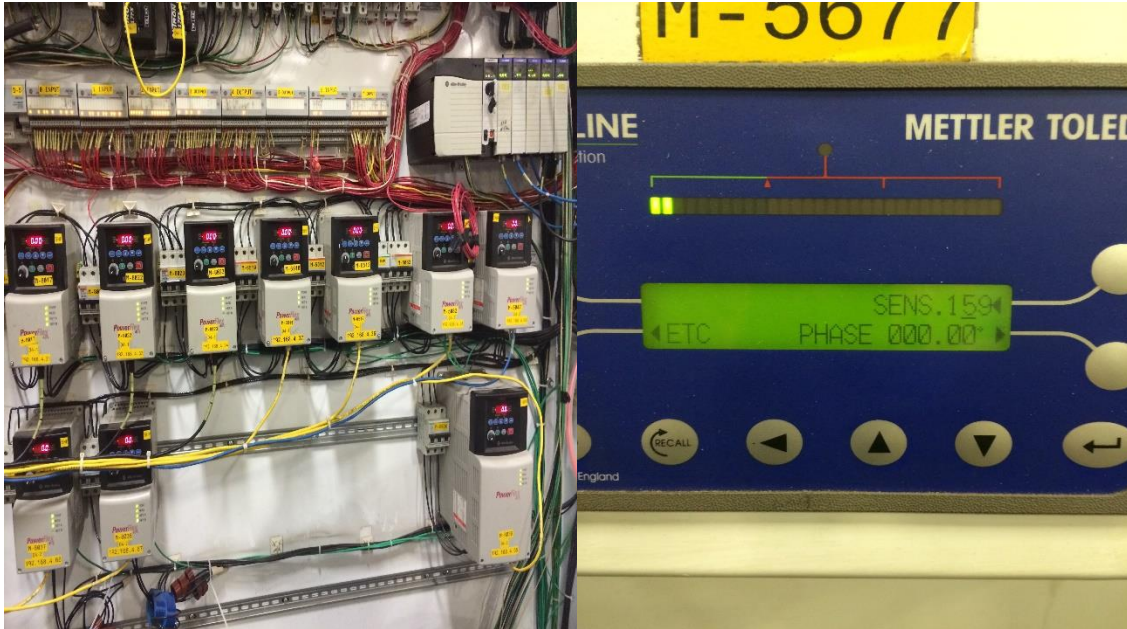
Photo 1

Control Panel and Metal Detector

Since installing CoolBLUE® and NaLA® cores on Line #8 metal detector, Big Heart Pet is now able use the metal detector at its higher sensitivity levels, with complete stability. Sensitivity range is from 0-199. The unit is now running at a sensitivity level of approximately 159.

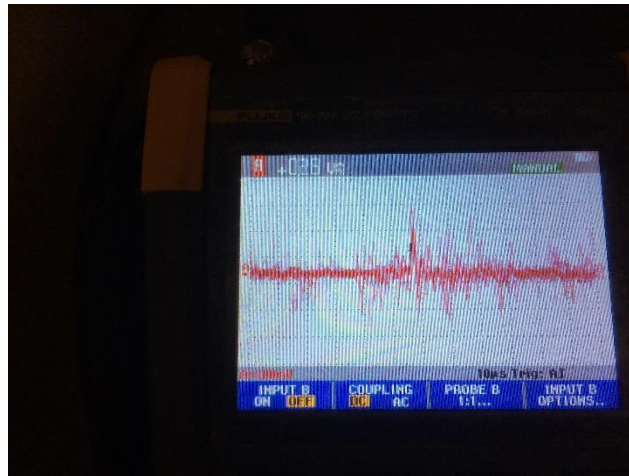
Photo 2 is in run mode on the Fluke 190 scope meter. This reading was taken with the Rogowski coil on L1-L2-L3 at the bottom of the master disconnect of control cabinet. Disconnect is rated at 100 amp.

Fluke 190 Scope Meter

The Fluke 190 Scope Meter (**Photo 2**) shows an excessive amount of High Frequency noise. All of this high frequency noise, high frequency current, is generated by the VFD's and transmitted throughout the plant. The VFD's are powering the electric motors to perform a certain job in the plant.

The High Frequency current/noise generated from the VFD's find a path to the electric motor, passed through the bearings in the motor, back through the ground wire, and then recirculated back through the plant.

All of this High Frequency current/noise then ends up back on the line side of the control cabinets, electric motors, VFD's etc.

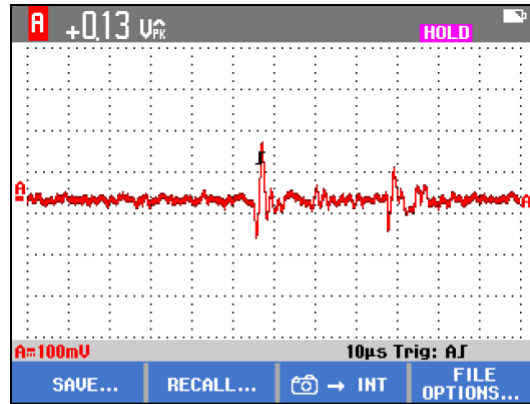
readings were taken at the bottom of the disconnect, with no coolBlue or Nala cores installed.
 .13~.05=2.6 amps of high frequency current.
 line#8 metal detector
 05/19/15 09:04:35 test#31

In **Figure 1**, the meter was put on hold to show how much High Frequency current was on the L1-L2-L3 at the bottom of disconnect. The Rogowski coil is used to capture the readings.

Figure 1 shows that there are .13 volts peak.

Rogowski conversion: .13 volt divided by .05 = 2.6 amps of current.

Note that this current is flowing on the incoming power to the control cabinet, L1-L2-L3. All of the VFD's, controls for the metal detector, etc., are all seeing this issue. This issue will affect the output power of the VFD.

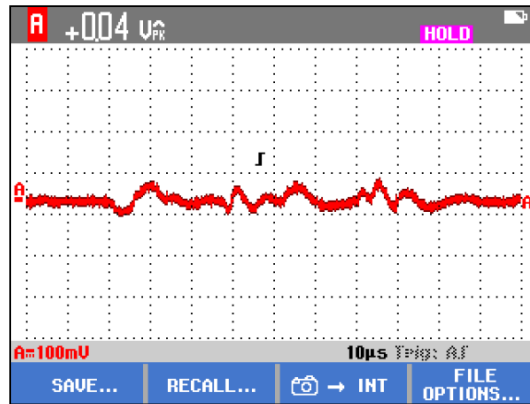
readings were taken at the bottom of the disconnect, with coolBlue and Nala cores installed.
 .04~.05=.8 amps of high frequency current.
 line #8 metal detector
 05/19/15 09:12:11 test # 32

Rogowski conversion: .04 divided by .05 = .8 amps of current.

Figure 2 shows the readings after the CoolBLUE® and the NaLA® cores were installed on the L1-L2-L3 below disconnect. Cores installed help clean up incoming power.

By removing the High Frequency current/noise, the metal detectors were able to maintain a setting and resolved the false readings.

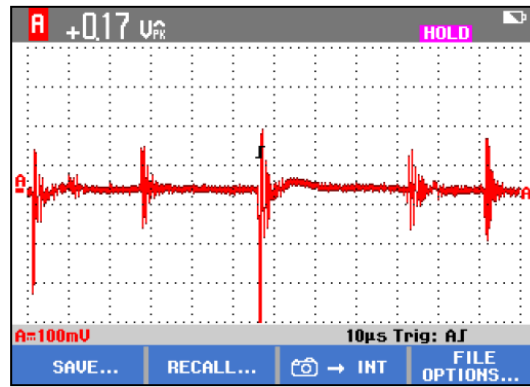
Figure 3

M8038
 readings were taken on T1-T2-T3 at
 the bottom of the VFD. with no
 coolBlue or Nalas installed.
 .17~.05=3.4 amps of current flowing
 through the bearings.
 line #8 metal detector
 05/19/15 09:16:50 test # 33

Readings were then taken on T1-T2-T3 on the wires between the VFD and the electric motor.

Rogowski conversion: .17 divided by .05 = 3.4 amps of current

3.4 amps of High Frequency current passing through the bearings in the motor. This High Frequency current is also being sent back to earth ground via shaft, bearing, motor case, to ground.

With the use of shaft grounding brushes, this same current is still being sent to earth ground. It was just redirected from passing through the motor bearings, to being passed through the shaft grounding brush to ground.

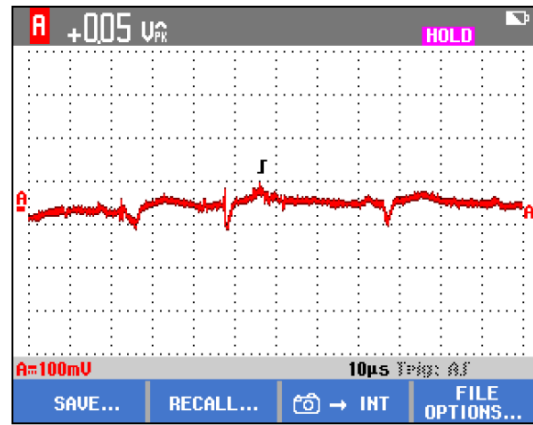
M8083
 reading taken on T1-T2-T3 with
 coolBlue and Nala cores installed.
 .05~.05= 1 amp of current flowing
 through the motor bearings.
 05/19/15 09:43:28 test # 34

Rogowski conversion: .05 divided by .05 = 1 amp of current

1 amp of current is being passed through the bearings in the motor, and then through the earth ground wire.

This is a decrease of 70% in High Frequency current.

Figure 4 shows the decrease in the High Frequency current after the CoolBLUE® and NaLA® cores were installed on T1-T2-T3.

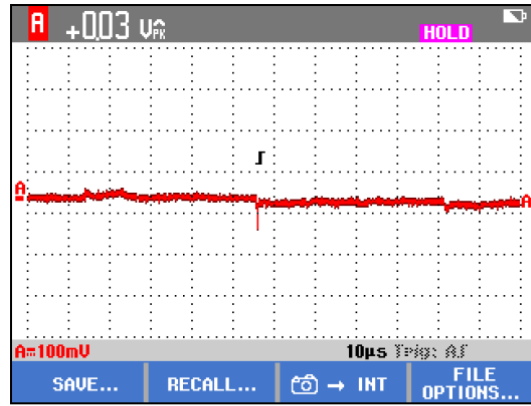
Figure 5

M8083
 reading taken on the ground wire.
 coolBlue and Nala cores intalled on
 T1-T2-T3
 .03~.05 = .6 amps on the ground wire
 05/19/15 09:46:11 test #35

Finally, **Figure 5** shows the amount of High Frequency current on the ground wire between the VFD and the electric motor.

Rogowski conversion: .03 divided by .05 = .6 amps of current

0.6 amps of current on the ground wire.
