CoolBLUE cores reduce common mode current levels from 52 Amps to <2 Amps on a 1500Hp DC Drive installation

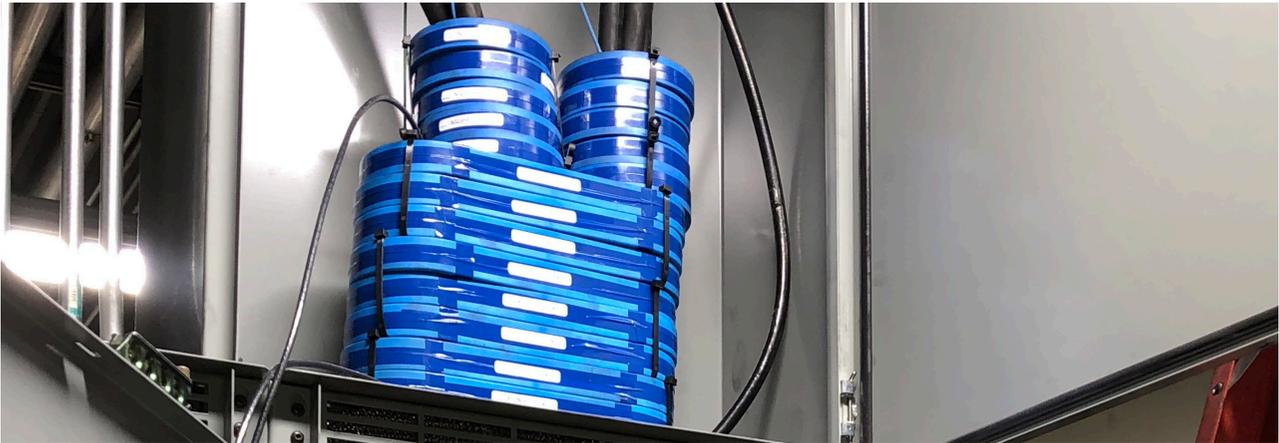
Horner Industrial's CoolBLUE Field Technician visited the site to take measurements on the output of the 1500Hp drive to determine the level of CoolBLUE protection that would be needed to protect all of the bearings in the system. He was shocked to find that the DC Drive was producing a whopping 52 amps, (2.60V).

The reading taken after the installation of the CoolBLUE cores on the output of the drive were below 2 amps, (80mV). This is a reduction of 96% in common mode currents being transmitted to the motor by the drive.

The Horner Industrial Field Service Team was recently called out to a Rubber Manufacturer to determine the cause of failure on their main mixer gearbox that was being powered by a 1500Hp DC Motor. This is the plant's main mixer that mixes all of the raw rubber material for the plant, whenever this mixer is down the plant is down. After the gearbox was torn down it was determined that the Drive End bearing of the gearbox failed due to bearing fluting caused by common mode currents. The common mode currents had travelled down the DC motor shaft, through the coupling, along the gearbox shaft and discharged to the gearbox frame through the Drive End bearing. It was also noted that this wasn't the first time this had happened. Horner Industrial's Salesperson made the customer aware of the cause of the problem and spoke of the high probability of the bearing failing again in the future if something wasn't done to make corrections to the problem. He suggested the customer install CoolBLUE cores to alleviate any future failures of this kind.

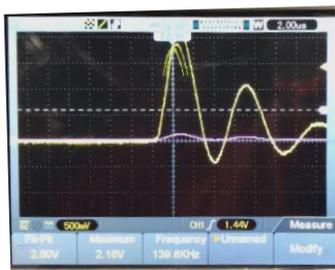
Before
CoolBLUE

After
CoolBLUE
